INDIAN ISLAND MOORINGS

PROJECT COMPLETION REPORT

FPO-1-79(9)

OCTOBER 1979

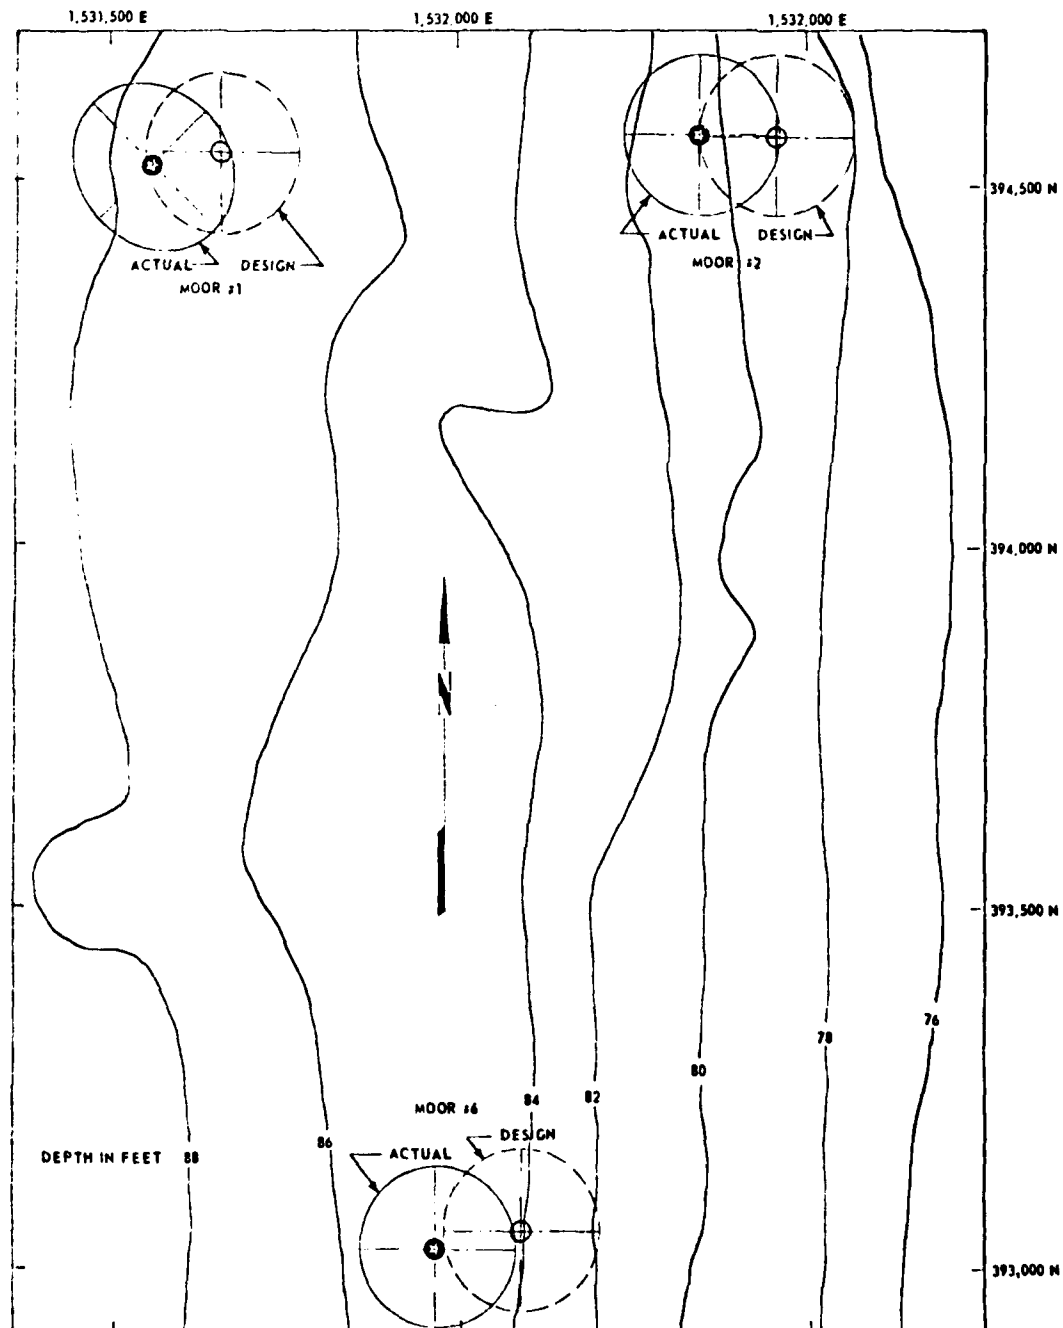
FIGURE 3

The installed locations of Moors #1, 2, and 6 are shown in Figure 3, together with depth contours derived from an earlier survey by Shannon & Wilson, Inc. The mean lower low water depths for the three moors are: #1 - 88 feet; #2 - 81 feet; #6 - 85 feet.

The design mooring circle radius for each moor was 235 feet, which comprised a buoy location tolerance of ± 20 feet, a watch circle radius of the buoy under 12 kip load of 50 feet, a bridle length of 75 feet, and a barge length of 110 feet. The design circles shown on Figure 3 show this radius without the ± 20 foot tolerance, i.e. a 215 foot radius. Based upon the pull test results it was found that Moors #2 and #6 had corresponding radii of 218 feet and 217 feet. The circle for Moor #1 was actually an ellipse with a major axis of 250 feet and a minor axis of 220 feet. Since all watch circles lay outside of the stipulated distances from shore installations and minimum separation arcs it was considered that the moors were installed in conformance with the basic requirements.

3 Feb.-1635: Testing was completed on all three moors at this point. An on-site project review was conducted to evaluate the relevant factors involved in the relocation of the moorings to correct the navigational errors that had resulted in the three moors being roughly 100 ft farther offshore than called for by the initial design. The tests demonstrated that the moorings were satisfactorily implanted and the stipulated watch circle diameters had been met with the designed horizontal load applied to the buoys. Furthermore, the minimum separation requirements had been met and there was adequate room to install the remaining three buoys of the overall system. As a result of this review a decision was made that there was no logical rationale that called for the relocation of the moorings. The tugs were therefore ordered to pick up the three sets of crown buoys thus completing the construction effort.

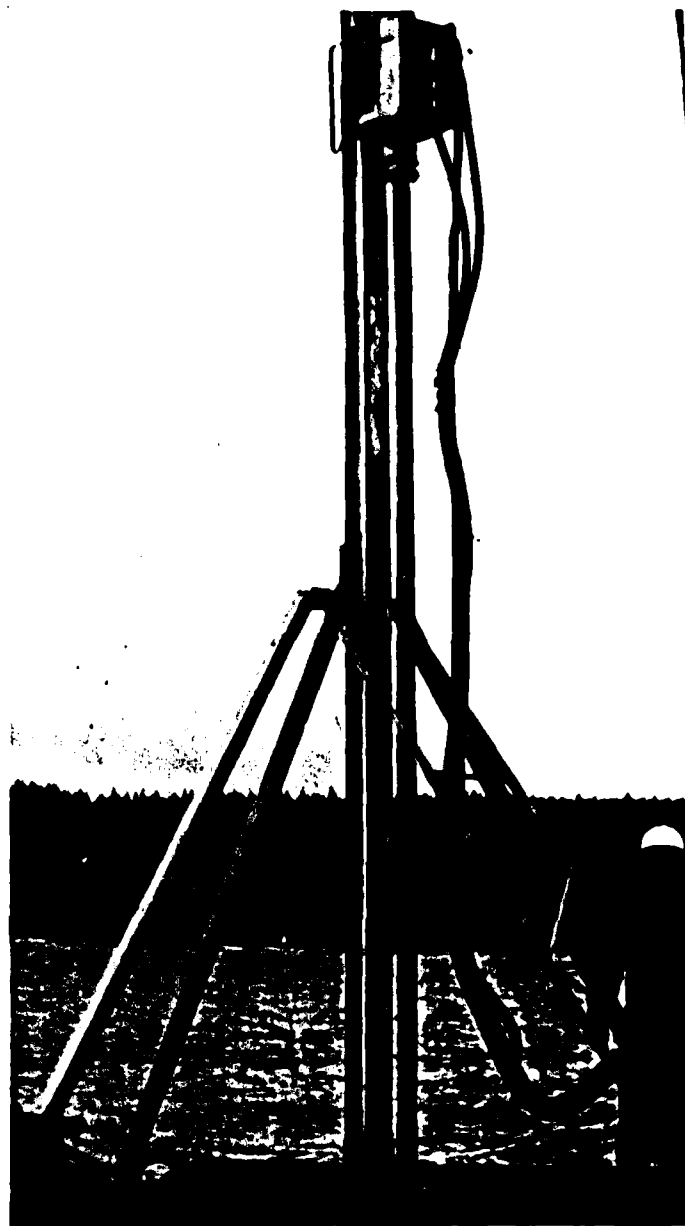
**VIBRACORER
FIGURE A-9**

24 Jan.-1307: The ST-2154 again got underway followed by the LT-2076 towing the BD-6650 Crane Barge with the Vibracorer aboard. Several attempts were made to hold the LT-2076 and Crane Barge on station with a 3,000 pound light weight anchor but the vessels continued to drift and drag anchor. Eventually, at 1445, the ST-2154 attempted to control the drift of the Crane Barge by pushing on the stern and, after holding location for about two minutes, it was decided to put the Vibracorer over the side, Figure A-9.

24 Jan.-1540: The LT-2076 tied up to the existing mooring and the Vibracorer was lowered into the water. CEL divers went down to obtain visual evidence that the Vibracorer was resting on the bottom after which they reported that although standing divers sank about 3 inches into the mud the Vibracorer pads still rested on top of the bottom

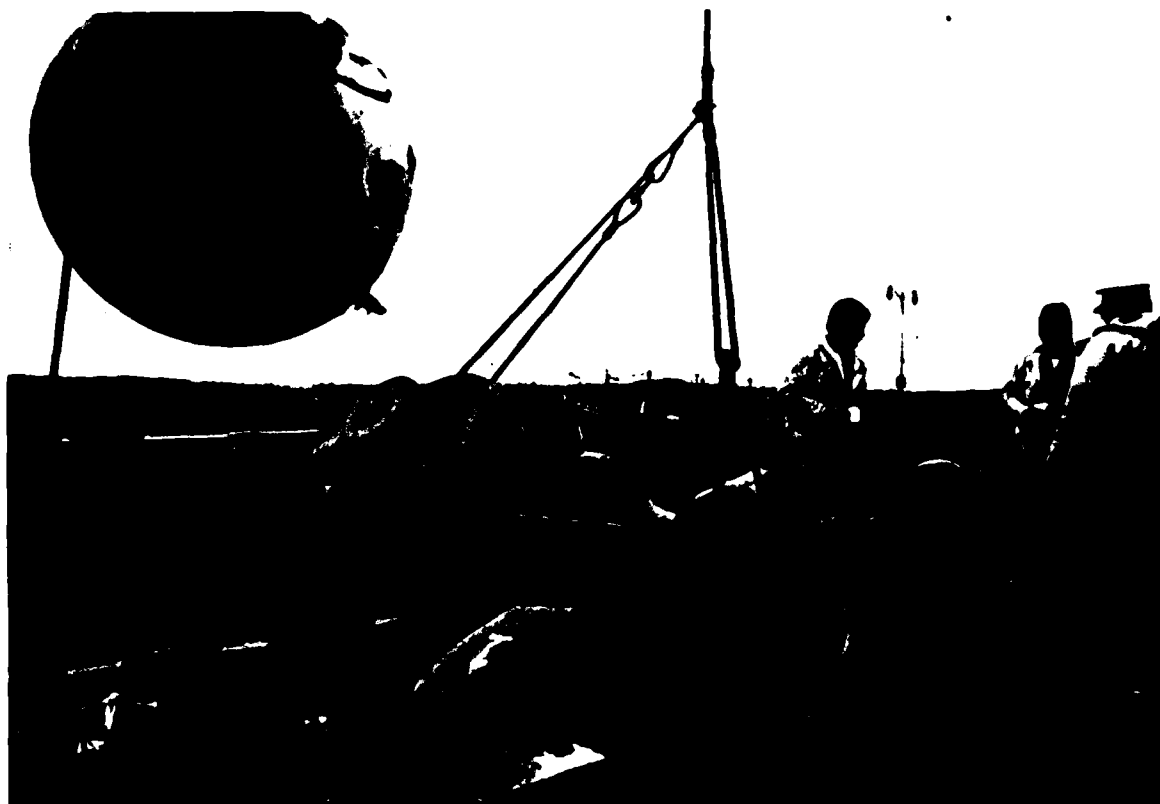
FIGURE A-17: ANCHOR RIGGED WITH BRIDLE FOR LOWERING OVERBOARD

At this point it should be mentioned that previous tests on the consistency of the bottom in the mooring area off Indian Island had indicated that normal anchor lowering and pulling into position might not be satisfactory. It had been decided that the Navy Stockless anchor flukes should be welded in an open position and that a bridle should be used for lowering the anchors from the crane in such a way that the flukes would sink directly into the bottom sediment oriented so that they would be installed in a position of maximum pulling force. The bridle system used for lowering should be such that, when pulling on the anchor crown, the flukes would remain pointed downward, and thus drop into a holding position in the bottom. The arrangement should be such that if the anchor were pulled horizontally by the crown or by the shank, the anchor would remain in a horizontal position with the flukes locked into the bottom. The bridle system is shown in Figure A-17 and the holding link is shown in Figure A-18. This was devised by PWC in such a manner that the application of a significant horizontal force either on the jews harp or on the crown would break the fabricated link.

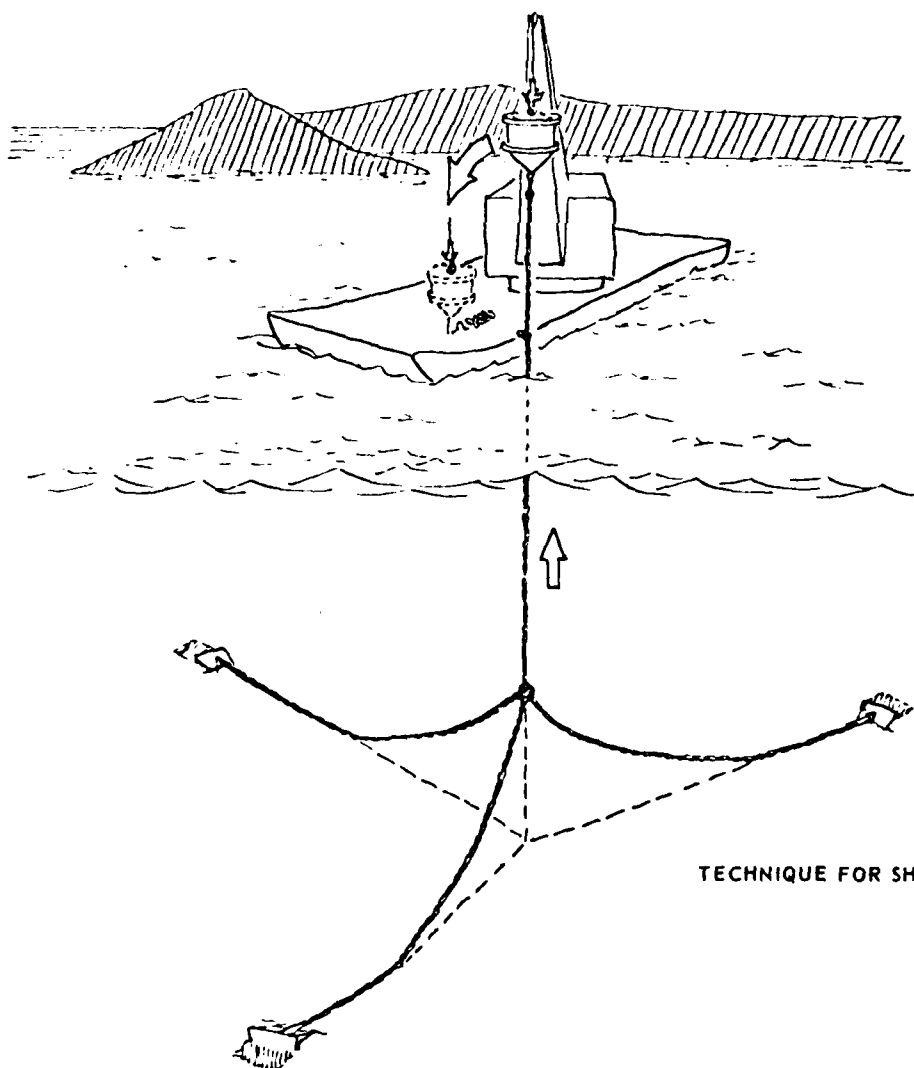
FIGURE A-37

3 Feb.-1230: The LT-2076 with the Crane Barge in tow proceeded back out to Moor #1 to shorten the riser chain which followed the same procedures as for the previous two moorings. This procedure is illustrated in Figure A-37.

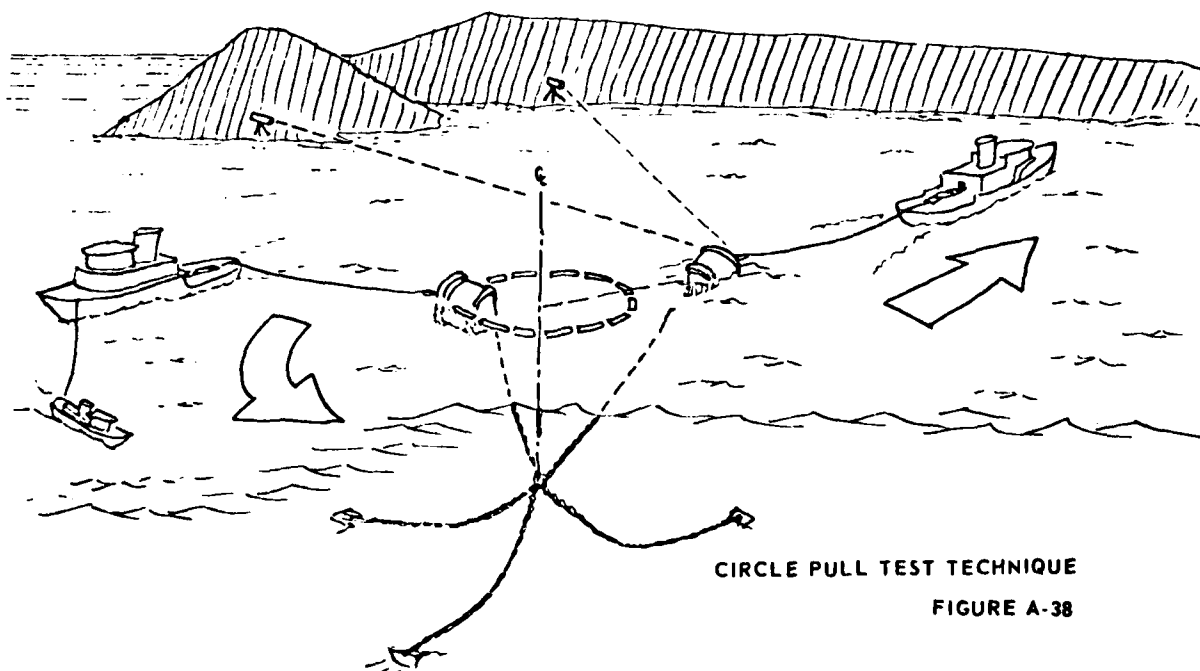
FIGURE A-38

3 Feb.-1320: The remainder of the day was spent in conducting pull tests on the three buoys. Figure A-38 illustrates the pull test technique. Figure A-39 illustrates a mooring buoy being pulled and the relative position of the dynamometer. Figure 40 is a closeup photograph of the Dillon dynamometer utilized for these tests. For each buoy a 6 kip circular test was conducted and then a 12 kip straight pull test was run with the pull in varying directions.

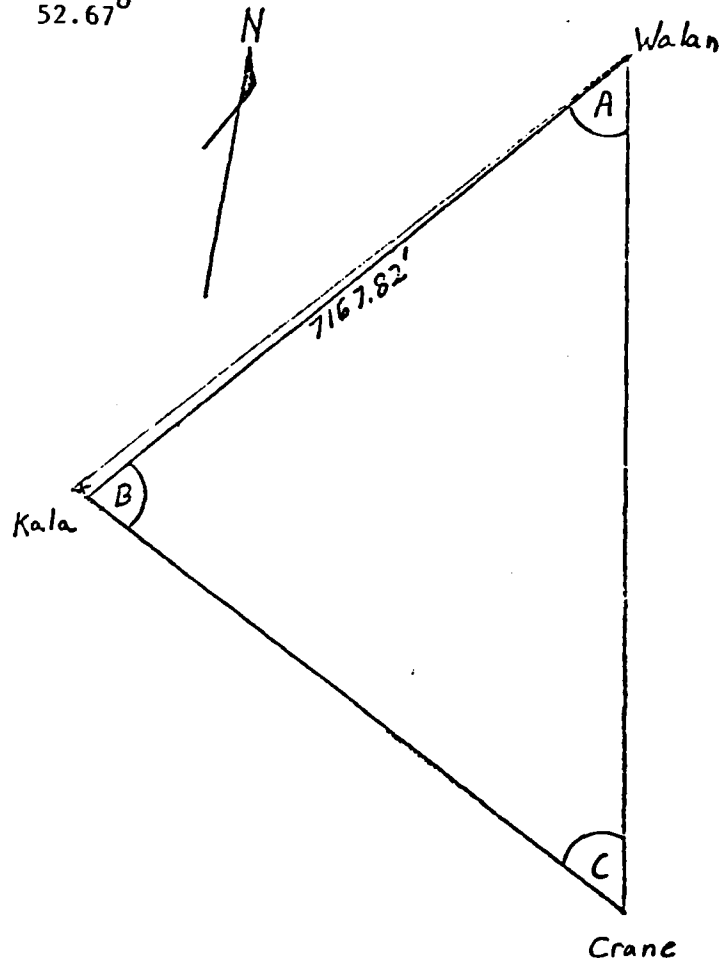
2. Difference between Calculated and Measured Angles of Triangle
Kala-Walan-Crane.

<u>ANGLE</u>	<u>CALCULATED</u>	<u>MEASURED</u>	<u>DIFFERENCE</u>
A	49.99°	51.23°	1.24°
B	77.34°	75.77°	1.57°
C	52.67°
